**Flood Control Project Maintenance
Levee Inspections****LMA District Cover Sheet****Spring 2014 Levee Inspection Results****American River Flood Control District**

Spring 2014 Levee Inspection Results

American River Flood Control District

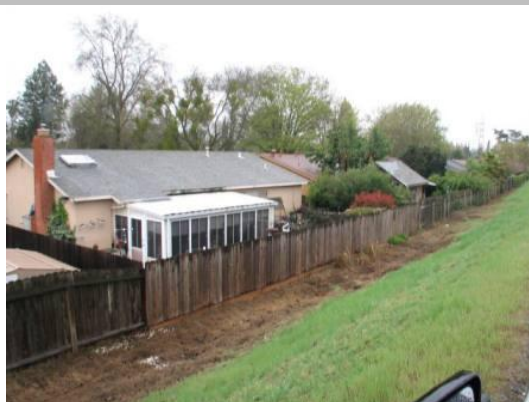
Photo 1 of 1 : mkhashch_s_20140428_00172.jpg

LM Start	8.67	Rating **	U	Issue No.	116
LM End	8.67	Issue Type +	En	Location *	LS
Category	Earthen Levee			GPS Latitude/Longitude	
				Start	End
Item	Encroachments			38.564133 °	38.564133 °
				-121.387318 °	-121.387318 °
DWR ID	DWR_NA0001_04_s _ 2012_116				
Action/Comments					
Fence Inspector Comments: Wood privacy fence within 10-ft of levee toe obstructs access and visibility.

03/16/2012 Wood privacy fence completely obstructs access and visibility.

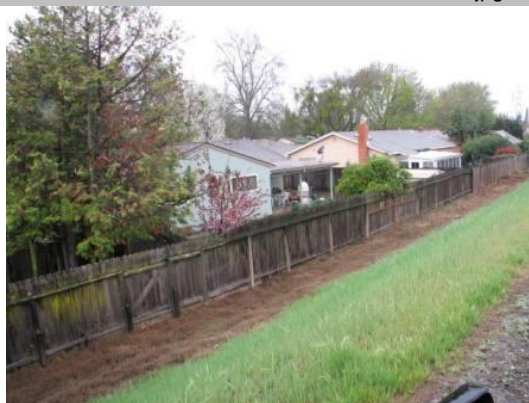
Photo 1 of 1 : mkhashch_s_20140428_00174.jpg

LM Start	8.68	Rating **	U	Issue No.	118
LM End	8.68	Issue Type +	En	Location *	LS
Category	Earthen Levee			GPS Latitude/Longitude	
				Start	End
Item	Encroachments			38.564133 °	38.564133 °
				-121.387092 °	-121.387092 °
DWR ID	DWR_NA0001_04_s _ 2012_118				
Action/Comments					
Fence Inspector Comments: Wood privacy fence within 10-ft of levee toe obstructs access and visibility.

03/16/2012 Wood privacy fence completely obstructs access and visibility.

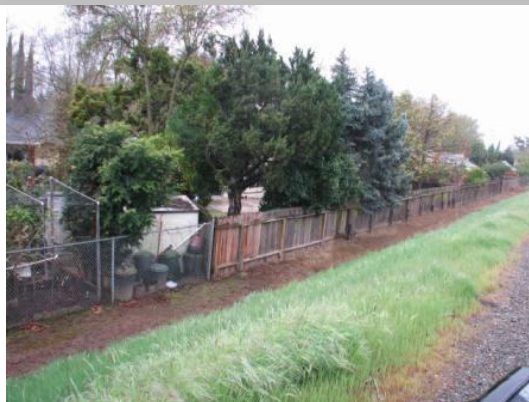
Photo 1 of 1 : mkhashch_s_20140428_00175.jpg

LM Start	8.70	Rating **	U	Issue No.	119
LM End	8.70	Issue Type +	En	Location *	LS
Category	Earthen Levee			GPS Latitude/Longitude	
				Start	End
Item	Encroachments			38.564217 °	38.564217 °
				-121.386846 °	-121.386846 °
DWR ID	DWR_NA0001_04_s _ 2012_119				
Action/Comments					
Fence					
Inspector Comments: Wood privacy fence within 10-ft of levee toe obstructs access and visibility.

03/16/2012 Wood privacy fence completely obstructs access and visibility.

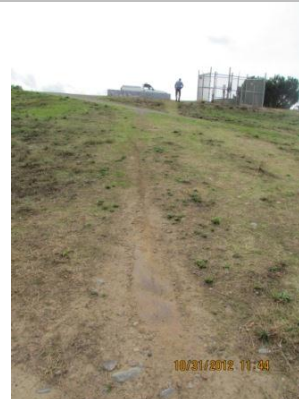
Photo 2 of 2 : mkhashch_s_20140428_00227.jpg

LM Start	9.49	Rating **	A/W	Issue No.	175 (cont)
LM End	9.49	Issue Type +	En	Location *	WS
Category	Earthen Levee			GPS Latitude/Longitude	
				Start	End
Item	Encroachments			38.566700 °	38.566700 °
				-121.372961 °	-121.372961 °
DWR ID	DWR_NA0001_04_s _ 2012_175				
Action/Comments					
Pipe					
Inspector Comments: Flap gates in good condition. Pipe is exposed at waterside toe.

View of exposed pipe at waterside toe.

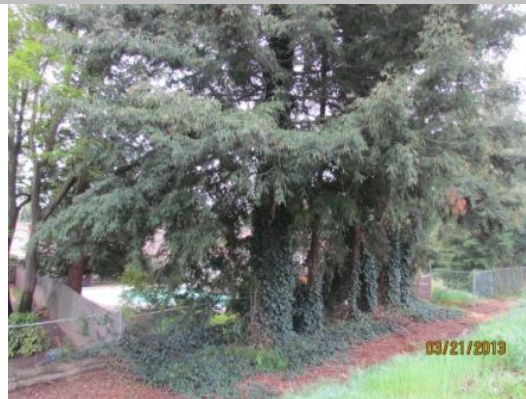
Photo 1 of 1 : mkhashch_s_20140428_00260.jpg

LM Start	9.57	Rating **	M	Issue No.	237
LM End	9.57	Issue Type +	En	Location *	LS
Category	Earthen Levee			GPS Latitude/Longitude	
				Start	End
Item	Vegetation			38.566938 °	38.566938 °
				-121.371550 °	-121.371550 °
DWR ID	DWR_NA0001_04_s _ 2012_237				
Action/Comments					
Landscaping Inspector Comments: Redwoods and ivy along fence within 10-ft of levee toe.

View of landscaping at levee toe.

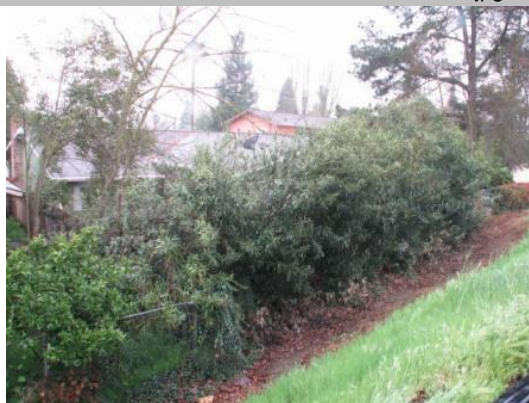
Photo 1 of 1 : mkhashch_s_20140428_00177.jpg

LM Start	9.61	Rating **	U	Issue No.	121
LM End	9.61	Issue Type +	En	Location *	LS
Category	Earthen Levee			GPS Latitude/Longitude	
				Start	End
Item	Vegetation			38.567058 °	38.567058 °
				-121.370954 °	-121.370954 °
DWR ID	DWR_NA0001_04_s _ 2012_121				
Action/Comments					
Landscaping Inspector Comments: Oleander bushes and shrubs within 10-ft of lanside toe.

03/16/2012 Landscaping obstructs visibility and access.

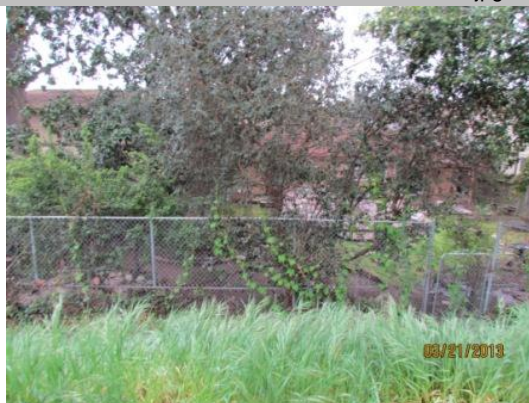
Photo 1 of 1 : mkhashch_s_20140428_00178.jpg

LM Start	9.64	Rating **	M	Issue No.	122
LM End	9.64	Issue Type +	En	Location *	LS
Category	Earthen Levee			GPS Latitude/Longitude	
				Start	End
Item	Vegetation			38.567181 °	38.567181 °
				-121.370366 °	-121.370366 °
DWR ID	DWR_NA0001_04_s _ 2012_122				
Action/Comments					
Landscaping Inspector Comments: Trees and ground cover within 10-ft of levee toe.

View of landscaping at levee toe.

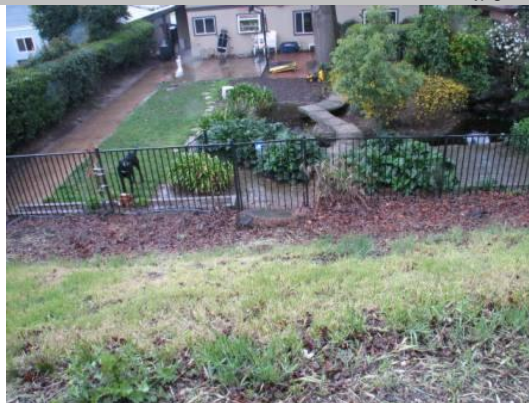
Photo 1 of 1 : mkhashch_s_20140428_00179.jpg

LM Start	9.66	Rating **	N	Issue No.	123
LM End	9.66	Issue Type +	Ma	Location *	LS
Category	Earthen Levee			GPS Latitude/Longitude	
				Start	End
Item	Trim / Thin Trees			38.567285 °	38.567285 °
				-121.369964 °	-121.369964 °
DWR ID	DWR_NA0001_04_s _ 2012_123				
Action/Comments					
Tree stumps. Inspector Comments: Trees, bushes and ground cover within 10-ft of levee toe.

03/16/2012 Large tree stump at levee toe.

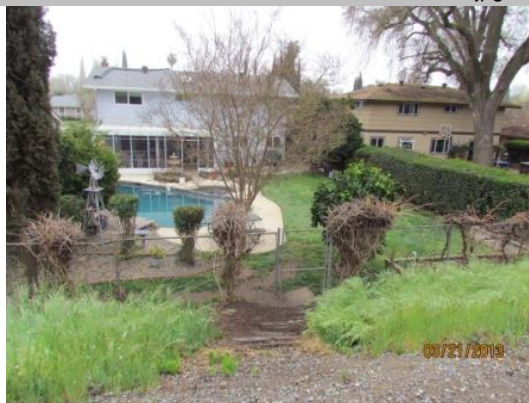
Photo 1 of 1 : mkhashch_s_20140428_00180.jpg

LM Start	9.67	Rating **	M	Issue No.	124
LM End	9.67	Issue Type +	En	Location *	LS
Category	Earthen Levee			GPS Latitude/Longitude	
				Start	End
Item	Vegetation			38.567242 °	38.567242 °
				-121.369858 °	-121.369858 °
DWR ID	DWR_NA0001_04_s_2012_124				
Action/Comments					
Landscaping Inspector Comments: Ivy and vines on chain link fence within 10-ft of levee toe.

View of landscaping at levee toe.

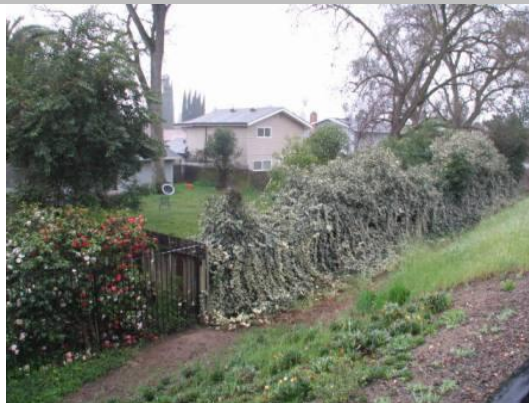
Photo 1 of 1 : mkhashch_s_20140428_00181.jpg

LM Start	9.69	Rating **	U	Issue No.	125
LM End	9.69	Issue Type +	En	Location *	LS
Category	Earthen Levee			GPS Latitude/Longitude	
				Start	End
Item	Vegetation			38.567360 °	38.567360 °
				-121.369555 °	-121.369555 °
DWR ID	DWR_NA0001_04_s_2012_125				
Action/Comments					
Landscaping Inspector Comments: Dense golden ivy on C/L fence obstructs access and visibility.

03/16/2012 Landscaping obstructs visibility and access.

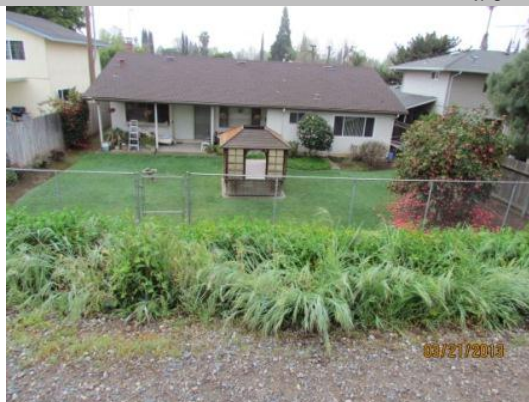
Photo 1 of 1 : mkhashch_s_20140428_00182.jpg

LM Start	9.72	Rating **	M	Issue No.	127
LM End	9.72	Issue Type +	En	Location *	LS
Category	Earthen Levee			GPS Latitude/Longitude	
				Start	End
Item	Vegetation			38.567451 °	38.567451 °
				-121.368962 °	-121.368962 °
DWR ID	DWR_NA0001_04_s_2012_127				
Action/Comments					
Landscaping Inspector Comments: Ground cover on levee slope.

View of landscaping on levee slope.

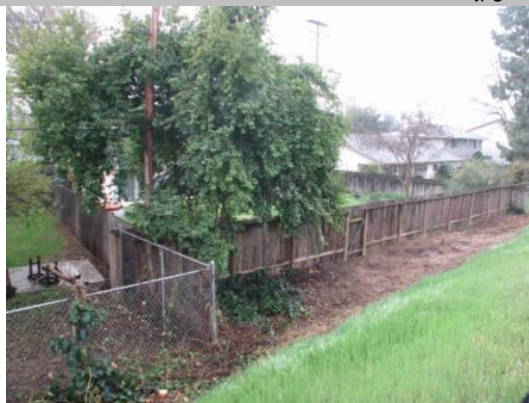
Photo 1 of 1 : mkhashch_s_20140428_00183.jpg

LM Start	9.74	Rating **	U	Issue No.	128
LM End	9.74	Issue Type +	En	Location *	LS
Category	Earthen Levee			GPS Latitude/Longitude	
				Start	End
Item	Encroachments			38.567493 °	38.567493 °
				-121.368633 °	-121.368633 °
DWR ID	DWR_NA0001_04_s _ 2012_128				
Action/Comments					
Fence					
Inspector Comments: Wooden privacy fence within 10-ft of levee toe.

03/16/2012 Wood privacy fence completely obstructs access and visibility.

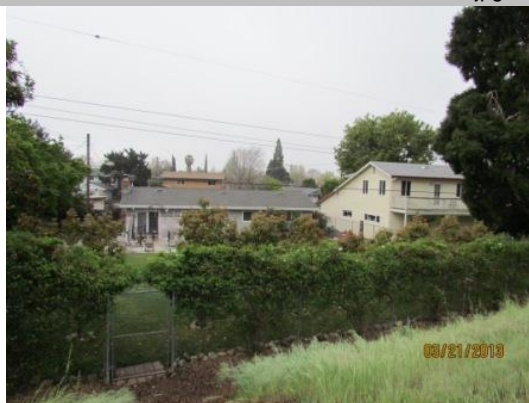
Photo 1 of 1 : mkhashch_s_20140428_00184.jpg

LM Start	9.76	Rating **	M	Issue No.	129
LM End	9.76	Issue Type +	En	Location *	LS
Category	Earthen Levee			GPS Latitude/Longitude	
				Start	End
Item	Vegetation			38.567594 °	38.567594 °
				-121.368195 °	-121.368195 °
DWR ID	DWR_NA0001_04_s _ 2012_129				
Action/Comments					
Landscaping					
Inspector Comments: Trees and vines along C/L fence within 10-ft of levee toe.

View of landscaping at levee toe.

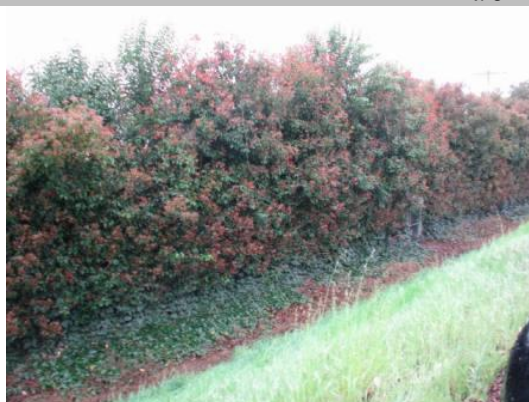
Photo 1 of 1 : mkhashch_s_20140428_00185.jpg

LM Start	9.78	Rating **	U	Issue No.	130
LM End	9.78	Issue Type +	En	Location *	LS
Category	Earthen Levee			GPS Latitude/Longitude	
				Start	End
Item	Vegetation			38.567626 °	38.567626 °
				-121.367921 °	-121.367921 °
DWR ID	DWR_NA0001_04_s _ 2012_130				
Action/Comments					
Landscaping					
Inspector Comments: Tall hedge obstructs access and visibility.

03/16/2012 Tall hedge obstructs visibility and access.

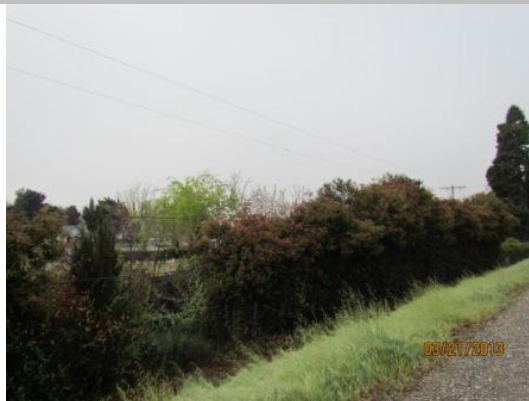
Photo 1 of 1 : mkhashch_s_20140428_00186.jpg

LM Start	9.79	Rating **	M	Issue No.	131
LM End	9.79	Issue Type +	En	Location *	LS
Category	Earthen Levee			GPS Latitude/Longitude	
				Start	End
Item	Vegetation			38.567680 °	38.567680 °
				-121.367674 °	-121.367674 °
DWR ID	DWR_NA0001_04_s _ 2012_131				
Action/Comments					
Landscaping					
Inspector Comments: Tall hedge obstructs access and visibility.

View of landscaping at levee toe.

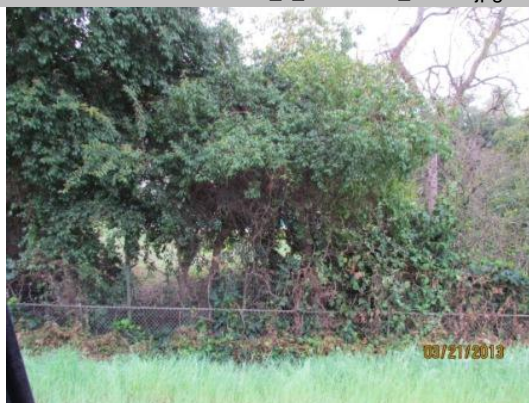
Photo 1 of 1 : mkhashch_s_20140428_00187.jpg

LM Start	9.82	Rating **	M	Issue No.	132
LM End	9.82	Issue Type +	En	Location *	LS
Category	Earthen Levee			GPS Latitude/Longitude	
				Start	End
Item	Vegetation			38.567772 °	38.567772 °
				-121.367227 °	-121.367227 °
DWR ID	DWR_NA0001_04_s _ 2012_132				
Action/Comments					
Landscaping					
Inspector Comments: Trees and ivy on levee slope obstruct access and visibility.

View of obstructive landscaping.

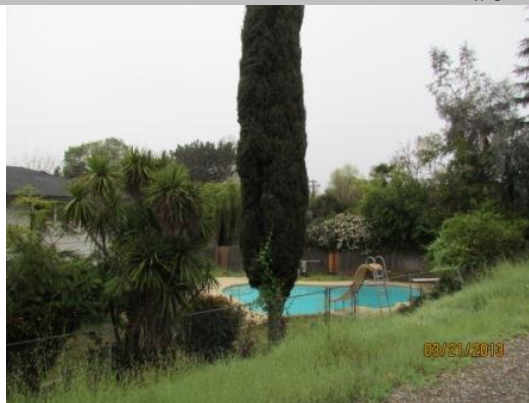
Photo 1 of 1 : mkhashch_s_20140428_00188.jpg

LM Start	9.84	Rating **	M	Issue No.	133
LM End	9.84	Issue Type +	En	Location *	LS
Category	Earthen Levee			GPS Latitude/Longitude	
				Start	End
Item	Vegetation			38.567856 °	38.567856 °
				-121.366892 °	-121.366892 °
DWR ID	DWR_NA0001_04_s _ 2012_133				
Action/Comments					
Landscaping					
Inspector Comments: Lemon tree, palm, sky pencil and ivy planted within 10-ft of levee toe obstructs access and visibility.

View of landscaping at levee toe.

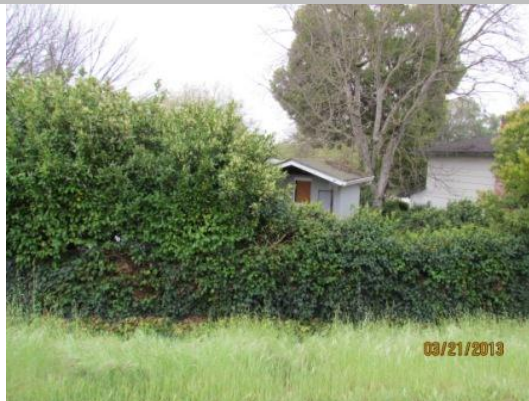
Photo 1 of 1 : mkhashch_s_20140428_00189.jpg

LM Start	9.86	Rating **	M	Issue No.	134
LM End	9.86	Issue Type +	En	Location *	LS
Category	Earthen Levee			GPS Latitude/Longitude	
				Start	End
Item	Vegetation			38.567873 °	38.567873 °
				-121.366410 °	-121.366410 °
DWR ID	DWR_NA0001_04_s _ 2012_134				
Action/Comments					
Landscaping					
Inspector Comments: Ivy, hedge and play house is within 10-ft of levee toe.

View of landscaping and playhouse.

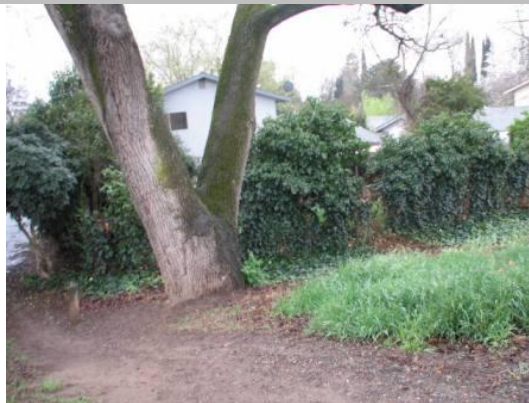
Photo 1 of 1 : mkhashch_s_20140428_00190.jpg

LM Start	9.98	Rating **	M	Issue No.	135
LM End	9.98	Issue Type +	En	Location *	LS
Category	Earthen Levee			GPS Latitude/Longitude	
				Start	End
Item	Vegetation			38.568446 °	38.568446 °
				-121.364385 °	-121.364385 °
DWR ID	DWR_NA0001_04_s _ 2012_135				
Action/Comments					
Landscaping					
Inspector Comments: Tall hedge and ivy within 10-ft of landside levee toe.

03/16/2012 Landscaping is obstructing visibility.

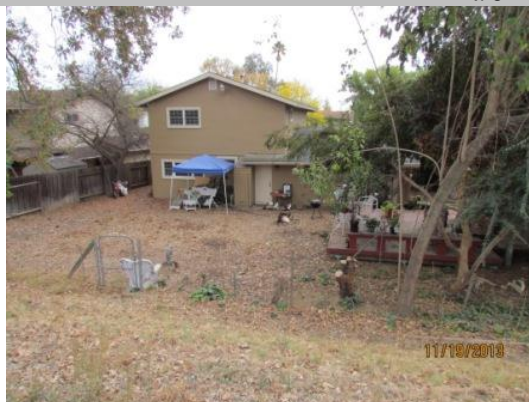
Photo 1 of 1 : mkhashch_s_20140428_00191.jpg

LM Start	10.04	Rating **	M	Issue No.	136
LM End	10.04	Issue Type +	En	Location *	LS
Category	Earthen Levee			GPS Latitude/Longitude	
				Start	End
Item	Encroachments			38.568714 °	38.568714 °
				-121.363257 °	-121.363257 °
DWR ID	DWR_NA0001_04_s _ 2012_136				
Action/Comments					
Fence					
Inspector Comments: Wire fence within 10-ft of landside levee toe.

View of the fence and tree stump at the landside levee toe.

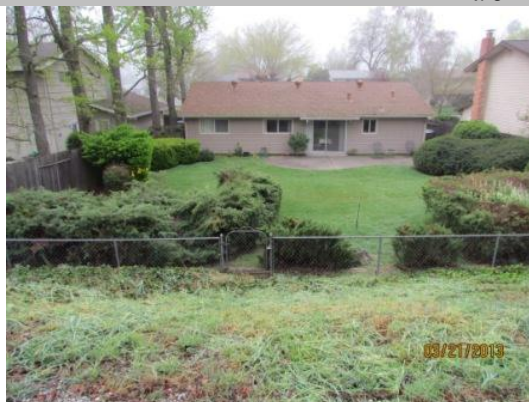
Photo 1 of 1 : mkhashch_s_20140428_00192.jpg

LM Start	10.07	Rating **	M	Issue No.	137
LM End	10.07	Issue Type +	En	Location *	LS
Category	Earthen Levee			GPS Latitude/Longitude	
				Start	End
Item	Vegetation			38.568833 °	38.568833 °
				-121.362783 °	-121.362783 °
DWR ID	DWR_NA0001_04_s_2012_137				
Action/Comments					
Landscaping Inspector Comments: Ivy on levee slope and Juniper at levee toe.

View of encroaching landscaping.

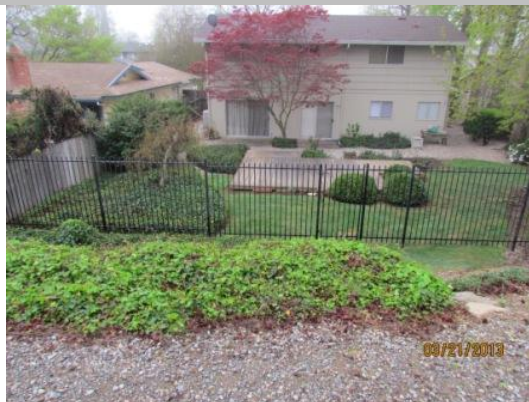
Photo 1 of 1 : mkhashch_s_20140428_00261.jpg

LM Start	10.09	Rating **	M	Issue No.	238
LM End	10.09	Issue Type +	En	Location *	LS
Category	Earthen Levee			GPS Latitude/Longitude	
				Start	End
Item	Vegetation			38.568918 °	38.568918 °
				-121.362533 °	-121.362533 °
DWR ID	DWR_NA0001_04_s_2012_238				
Action/Comments					
Landscaping					
Inspector Comments: Landscaping on levee slope.

View of the landscaping on levee slope.

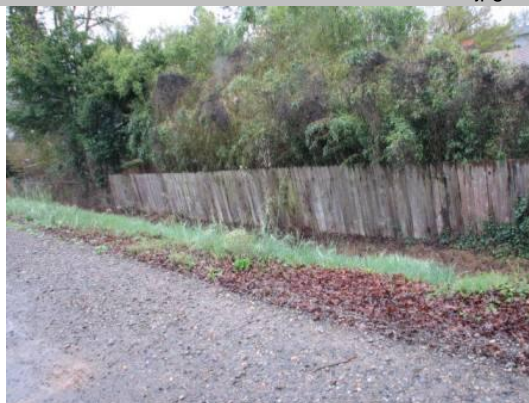
Photo 1 of 1 : mkhashch_s_20140428_00193.jpg

LM Start	10.10	Rating **	U	Issue No.	138
LM End	10.10	Issue Type +	En	Location *	LS
Category	Earthen Levee			GPS Latitude/Longitude	
				Start	End
Item	Encroachments			38.568953 °	38.568953 °
				-121.362396 °	-121.362396 °
DWR ID	DWR_NA0001_04_s _ 2012_138				
Action/Comments					
Fence					
Inspector Comments: 03/16/2012 Wood privacy fence completely obstructs visibility and access.

03/16/2012 Wood privacy fence completely obstructs access and visibility.

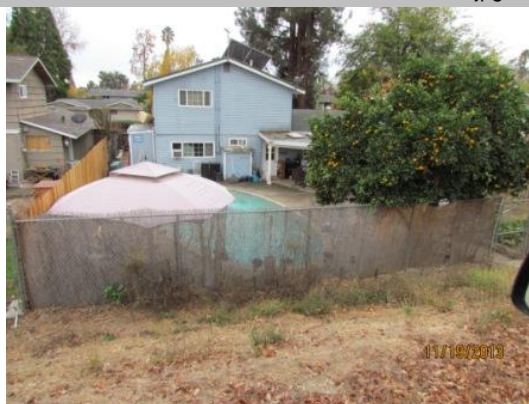
Photo 1 of 1 : mkhashch_s_20140428_00248.jpg

LM Start	10.12	Rating **	A/W	Issue No.	202
LM End	10.12	Issue Type +	En	Location *	LS
Category	Earthen Levee			GPS Latitude/Longitude	
				Start	End
Item	Encroachments			38.569111 °	38.569111 °
				-121.361921 °	-121.361921 °
DWR ID	DWR_NA0001_04_s _ 2013_202				
Action/Comments					
Pool					
Inspector Comments: Pool filled with water.

View of the pool filled with water.

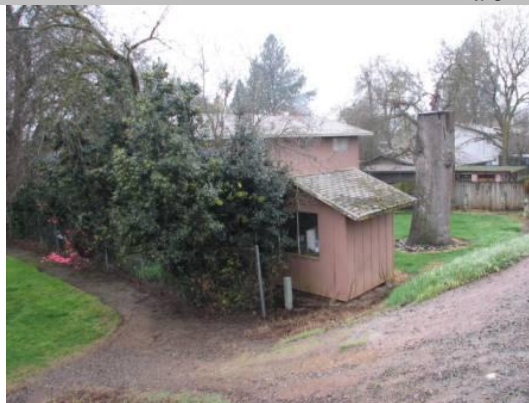
Photo 1 of 1 : mkhashch_s_20140428_00228.jpg

LM Start	10.18	Rating **	U	Issue No.	176
LM End	10.18	Issue Type +	En	Location *	LS
Category	Earthen Levee			GPS Latitude/Longitude	
				Start	End
Item	Encroachments			38.569293 °	38.569293 °
				-121.361002 °	-121.361002 °
DWR ID	DWR_NA0001_04_s _ 2012_176				
Action/Comments					
Building

03/16/2012 Wood structure within 15' of levee toe.

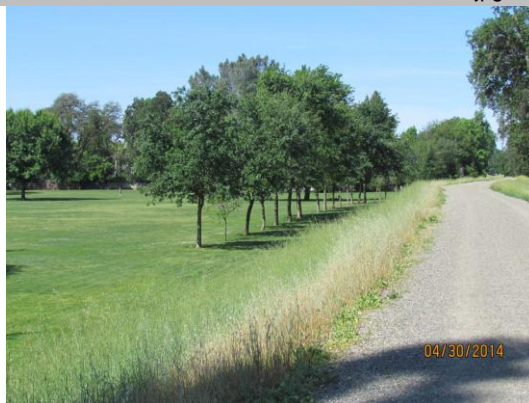
Photo 1 of 1 : mkhashch_s_20140509_00970.jpg

View of the tall vegetation on the landside levee slope.

LM Start	10.32	Rating **	M	Issue No.	243
LM End	10.32	Issue Type +	Ma	Location *	LS
Category	Earthen Levee			GPS Latitude/Longitude	
				Start	End
Item	Vegetation			38.569902 °	38.569902 °
				-121.358491 °	-121.358491 °
DWR ID	DWR_NA0001_04_s _ 2014_243				
Action/Comments					
Control annual grass and weeds on the levee slopes and easements.

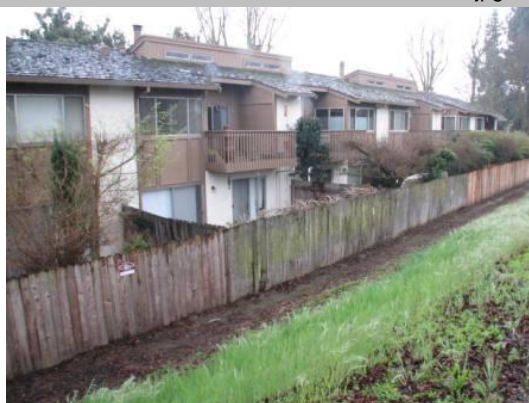
Photo 1 of 1 : mkhashch_s_20140428_00195.jpg

LM Start	10.34	Rating **	U	Issue No.	141
LM End	10.37	Issue Type +	En	Location *	LS
Category	Earthen Levee			GPS Latitude/Longitude	
				Start	End
Item	Encroachments			38.569982 °	38.570118 °
				-121.358134 °	-121.357604 °
DWR ID	DWR_NA0001_04_s _ 2012_141				
Action/Comments					
Fence					
Inspector Comments: Wooden fence behind six apartment units is within 10-ft of levee slope.

03/16/2012 Wood privacy fence completely obstructs access and visibility.

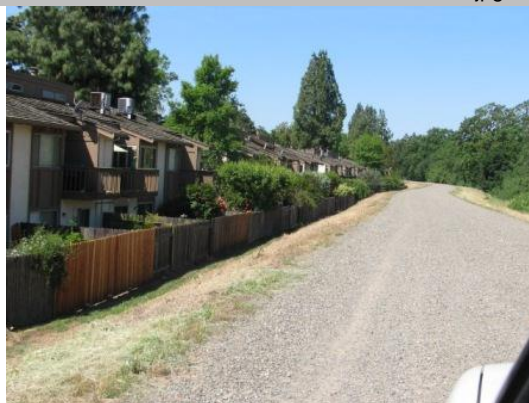
Photo 1 of 1 : mkhashch_s_20140428_00196.jpg

LM Start	10.38	Rating **	U	Issue No.	142
LM End	10.40	Issue Type +	En	Location *	LS
Category	Earthen Levee			GPS Latitude/Longitude	
				Start	End
Item	Encroachments			38.570175 °	38.570229 °
				-121.357390 °	-121.357041 °
DWR ID	DWR_NA0001_04_s _ 2012_142				
Action/Comments					
Fence Inspector Comments: Wooden fence behind six apartment units is within 10-ft of levee slope.

Wooden fence behind apartments within 10' of levee toe.

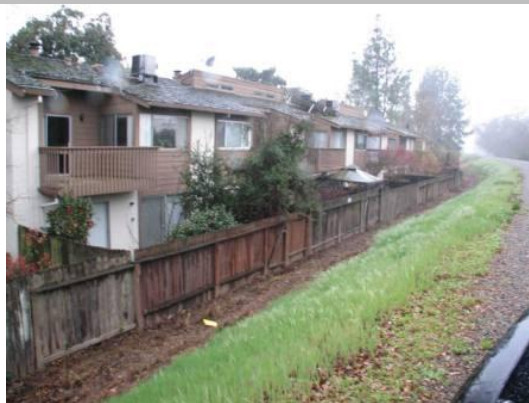
Photo 1 of 1 : mkhashch_s_20140428_00200.jpg

LM Start	10.41	Rating **	U	Issue No.	146
LM End	10.42	Issue Type +	En	Location *	LS
Category	Earthen Levee			GPS Latitude/Longitude	
				Start	End
Item	Encroachments			38.570225 °	38.570245 °
				-121.357014 °	-121.356791 °
DWR ID	DWR_NA0001_04_s _ 2012_146				
Action/Comments					
Fence					
Inspector Comments: Wooden fence behind 6 apartments.

03/16/2012 Wood privacy fence completely obstructs access and visibility.

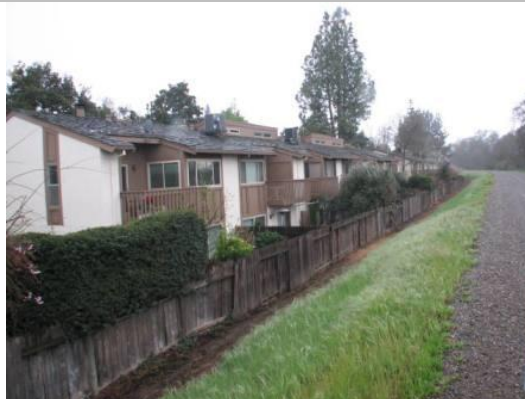
Photo 1 of 1 : mkhashch_s_20140428_00197.jpg

LM Start	10.42	Rating **	U	Issue No.	143
LM End	10.44	Issue Type +	En	Location *	LS
Category	Earthen Levee			GPS Latitude/Longitude	
				Start	End
Item	Encroachments			38.570257 °	38.570297 °
				-121.356783 °	-121.356403 °
DWR ID	DWR_NA0001_04_s_2012_143				
Action/Comments					
Fence Inspector Comments: Wooden fence behind six apartment units is within 10-ft of levee slope.

03/16/2012 Wood privacy fence completely obstructs access and visibility.

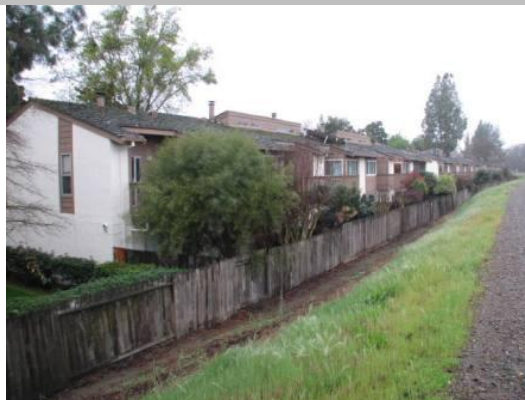
Photo 1 of 1 : mkhashch_s_20140428_00198.jpg

LM Start	10.45	Rating **	U	Issue No.	144
LM End	10.48	Issue Type +	En	Location *	LS
Category	Earthen Levee			GPS Latitude/Longitude	
				Start	End
Item	Encroachments			38.570325 °	38.570397 °
				-121.356185 °	-121.355757 °
DWR ID	DWR_NA0001_04_s_2012_144				
Action/Comments					
Fence					
Inspector Comments: Wooden fence behind six apartment units is within 10-ft of levee slope.

03/16/2012 Wood privacy fence completely obstructs access and visibility.

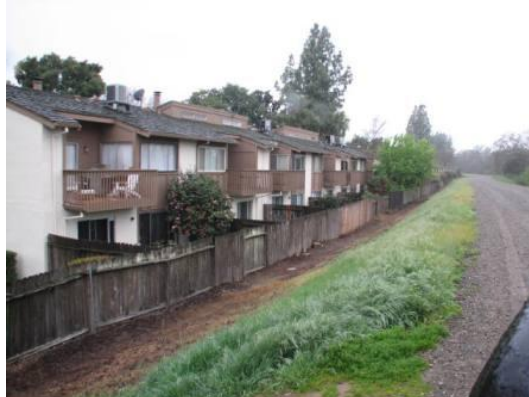
Photo 1 of 1 : mkhashch_s_20140428_00199.jpg

LM Start	10.48	Rating **	U	Issue No.	145
LM End	10.51	Issue Type +	En	Location *	LS
Category	Earthen Levee			GPS Latitude/Longitude	
				Start	End
Item	Encroachments			38.570417 °	38.570500 °
				-121.355625 °	-121.355151 °
DWR ID	DWR_NA0001_04_s _ 2012_145				
Action/Comments					
Fence Inspector Comments: Wooden fence behind six apartment units is within 10-ft of levee slope.

03/16/2012 Wood privacy fence completely obstructs access and visibility.

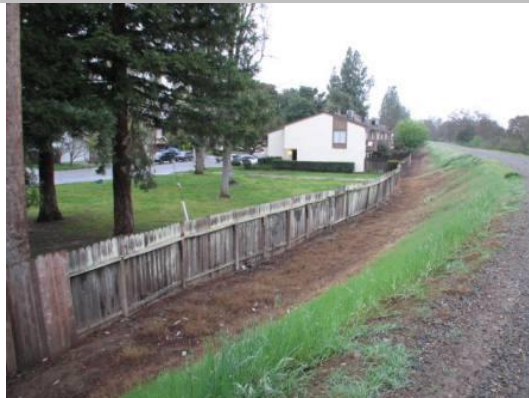
Photo 1 of 1 : mkhashch_s_20140428_00201.jpg

LM Start	10.53	Rating **	U	Issue No.	147
LM End	10.53	Issue Type +	En	Location *	LS
Category	Earthen Levee			GPS Latitude/Longitude	
				Start	End
Item	Encroachments			38.570542 °	38.570542 °
				-121.354772 °	-121.354772 °
DWR ID	DWR_NA0001_04_s _ 2012_147				
Action/Comments					
Fence					
Inspector Comments: Wooden privacy fence.

03/16/2012 Wood privacy fence completely obstructs access and visibility.

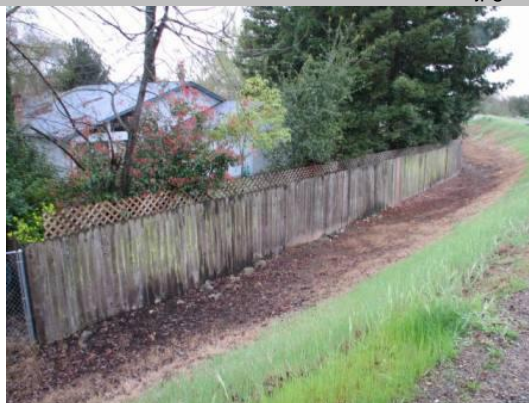
Photo 1 of 1 : mkhashch_s_20140428_00202.jpg

LM Start	10.56	Rating **	U	Issue No.	148
LM End	10.56	Issue Type +	En	Location *	LS
Category	Earthen Levee			GPS Latitude/Longitude	
				Start	End
Item	Encroachments			38.570524 °	38.570524 °
				-121.354359 °	-121.354359 °
DWR ID	DWR_NA0001_04_s _ 2012_148				
Action/Comments					
Fence Inspector Comments: Wooden privacy fence obstructs visibility and access.

03/16/2012 Wood privacy fence completely obstructs access and visibility.

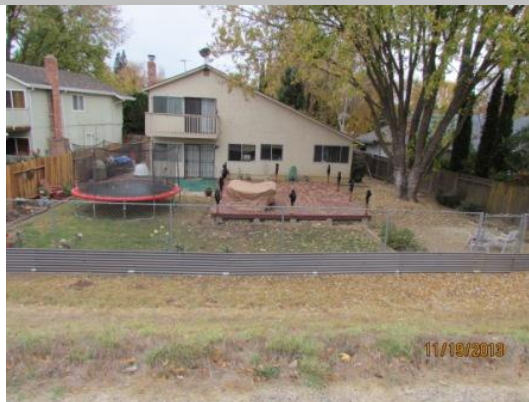
Photo 1 of 1 : mkhashch_s_20140428_00232.jpg

LM Start	10.57	Rating **	M	Issue No.	180
LM End	10.57	Issue Type +	En	Location *	LS
Category	Earthen Levee			GPS Latitude/Longitude	
				Start	End
Item	Encroachments			38.570397 °	38.570397 °
				-121.354084 °	-121.354084 °
DWR ID	DWR_NA0001_04_s _ 2012_180				
Action/Comments					
Fence					
Inspector Comments: Chainlink fence partially obstructs, currently visibility is unobstructed.

Chainlink fence is partially obstructing visibility and access.

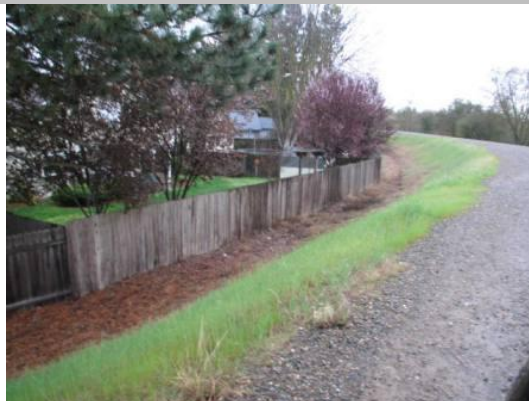
Photo 1 of 1 : mkhashch_s_20140428_00203.jpg

LM Start	10.58	Rating **	U	Issue No.	149
LM End	10.58	Issue Type +	En	Location *	LS
Category	Earthen Levee			GPS Latitude/Longitude	
				Start	End
Item	Encroachments			38.570234 °	38.570234 °
				-121.353862 °	-121.353862 °
DWR ID	DWR_NA0001_04_s _ 2012_149				
Action/Comments					
Fence					
Inspector Comments: Wooden privacy fence is within 10-ft of levee toe.

03/16/2012 Wood privacy fence completely obstructs access and visibility.

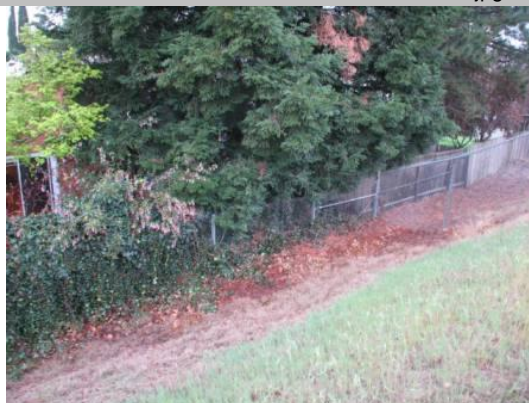
Photo 1 of 1 : mkhashch_s_20140428_00204.jpg

LM Start	10.60	Rating **	U	Issue No.	150
LM End	10.60	Issue Type +	En	Location *	LS
Category	Earthen Levee			GPS Latitude/Longitude	
				Start	End
Item	Encroachments			38.570095 °	38.570095 °
				-121.353807 °	-121.353807 °
DWR ID	DWR_NA0001_04_s _ 2012_150				
Action/Comments					
Fence					
Inspector Comments: Wooden privacy fence within 10-ft of levee toe.

03/16/2012 Wood privacy fence completely obstructs access and visibility.

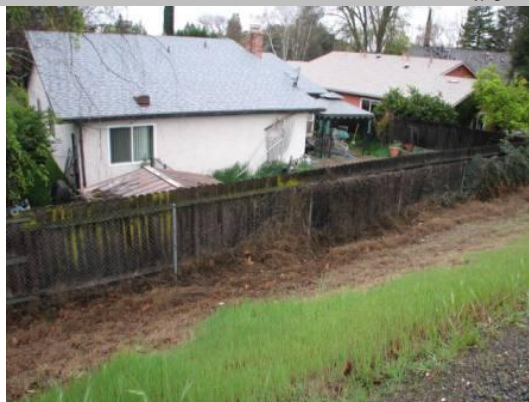
Photo 1 of 1 : mkhashch_s_20140428_00205.jpg

LM Start	10.62	Rating **	U	Issue No.	151
LM End	10.62	Issue Type +	En	Location *	LS
Category	Earthen Levee			GPS Latitude/Longitude	
				Start	End
Item	Encroachments			38.569921 °	38.569921 °
				-121.353643 °	-121.353643 °
DWR ID	DWR_NA0001_04_s _ 2012_151				
Action/Comments					
Fence					
Inspector Comments: Wooden privacy fence within 10-ft of levee toe.

03/16/2012 Wood privacy fence completely obstructs access and visibility.

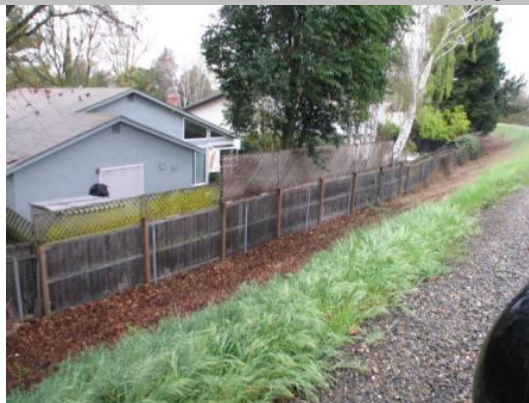
Photo 1 of 1 : mkhashch_s_20140428_00206.jpg

LM Start	10.63	Rating **	U	Issue No.	152
LM End	10.63	Issue Type +	En	Location *	LS
Category	Earthen Levee			GPS Latitude/Longitude	
				Start	End
Item	Encroachments			38.569758 °	38.569758 °
				-121.353535 °	-121.353535 °
DWR ID	DWR_NA0001_04_s _ 2012_152				
Action/Comments					
Fence					
Inspector Comments: Wooden privacy fence within 10-ft of levee toe.

03/16/2012 Wood privacy fence completely obstructs access and visibility.

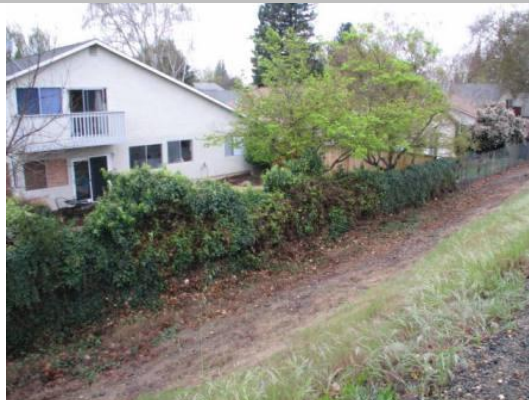
Photo 1 of 1 : mkhashch_s_20140428_00207.jpg

LM Start	10.67	Rating **	U	Issue No.	153
LM End	10.67	Issue Type +	En	Location *	LS
Category	Earthen Levee			GPS Latitude/Longitude	
				Start	End
Item	Encroachments			38.569166 °	38.569166 °
				-121.353272 °	-121.353272 °
DWR ID	DWR_NA0001_04_s _ 2012_153				
Action/Comments					
Fence					
Inspector Comments: Wooden privacy fence and ivy within 10-ft of levee toe.

03/16/2012 Wood privacy fence completely obstructs access and visibility.

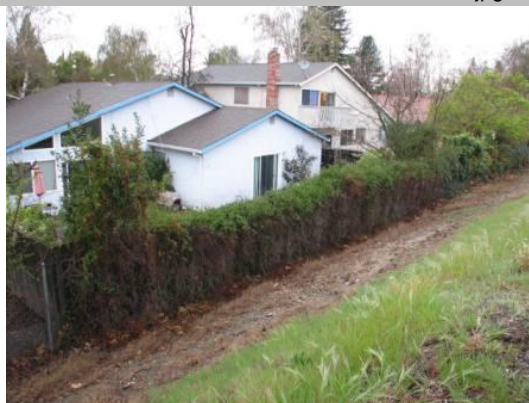
Photo 1 of 1 : mkhashch_s_20140428_00208.jpg

LM Start	10.68	Rating **	U	Issue No.	154
LM End	10.68	Issue Type +	En	Location *	LS
Category	Earthen Levee			GPS Latitude/Longitude	
				Start	End
Item	Encroachments			38.569020 °	38.569020 °
				-121.353313 °	-121.353313 °
DWR ID	DWR_NA0001_04_s_2012_154				
Action/Comments					
Fence					
Inspector Comments: Wooden privacy fence within 10-ft of levee toe.

03/16/2012 Wood privacy fence completely obstructs access and visibility.

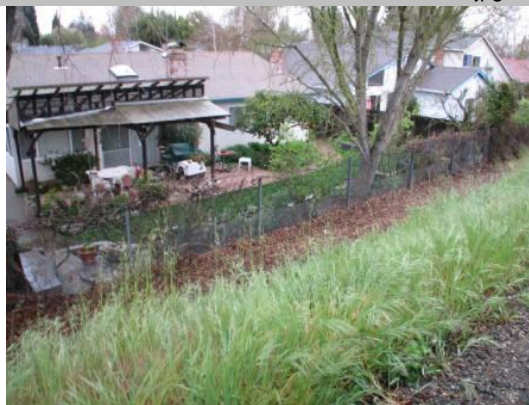
Photo 1 of 1 : mkhashch_s_20140428_00209.jpg

LM Start	10.69	Rating **	M	Issue No.	155
LM End	10.69	Issue Type +	En	Location *	LS
Category	Earthen Levee			GPS Latitude/Longitude	
				Start	End
Item	Vegetation			38.568892 °	38.568892 °
				-121.353162 °	-121.353162 °
DWR ID	DWR_NA0001_04_s_2012_155				
Action/Comments					
Landscaping					
Inspector Comments: Trees and bushes are within 10-ft of the levee toe.

03/16/2012 Trees and bushes within 10' of levee toe.

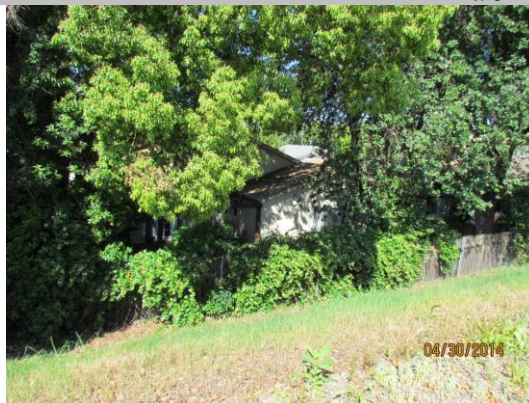
Photo 1 of 1 : mkhashch_s_20140509_00969.jpg

LM Start	10.71	Rating **	U	Issue No.	156
LM End	10.71	Issue Type +	En	Location *	LS
Category	Earthen Levee			GPS Latitude/Longitude	
				Start	End
Item	Encroachments			38.568713 °	38.568713 °
				-121.353150 °	-121.353150 °
DWR ID	DWR_NA0001_04_s_2012_156				
Action/Comments					
Fence					
Inspector Comments: Wooden privacy fence and landscaping within 10-ft of levee toe.

View of the fence at the landside levee toe obstructing visibility and access.

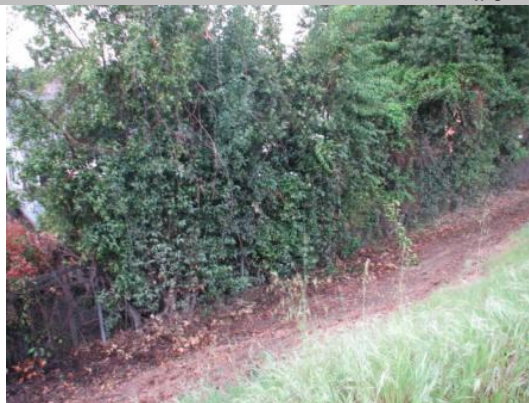
Photo 1 of 1 : mkhashch_s_20140428_00211.jpg

LM Start	10.71	Rating **	M	Issue No.	157
LM End	10.71	Issue Type +	En	Location *	LS
Category	Earthen Levee			GPS Latitude/Longitude	
				Start	End
Item	Vegetation			38.568608 °	38.568608 °
				-121.353054 °	-121.353054 °
DWR ID	DWR_NA0001_04_s _ 2012_157				
Action/Comments					
Landscaping					
Inspector Comments: Tall hedge and vine on levee toe.

03/16/2012 Landscaping obstructs visibility

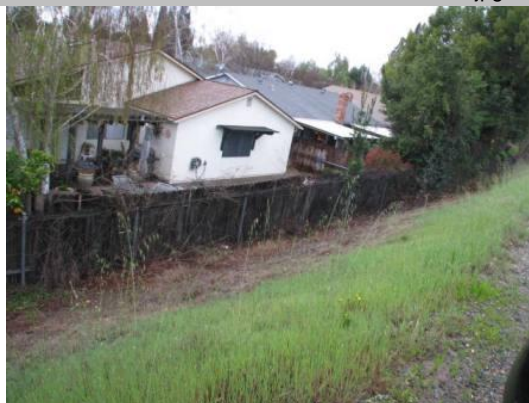
Photo 1 of 1 : mkhashch_s_20140428_00212.jpg

LM Start	10.73	Rating **	U	Issue No.	158
LM End	10.73	Issue Type +	En	Location *	LS
Category	Earthen Levee			GPS Latitude/Longitude	
				Start	End
Item	Encroachments			38.568355 °	38.568355 °
				-121.353033 °	-121.353033 °
DWR ID	DWR_NA0001_04_s _ 2012_158				
Action/Comments					
Fence					
Inspector Comments: Wooden privacy fence within 10-ft of levee toe.

03/16/2012 Wood privacy fence completely obstructs access and visibility.

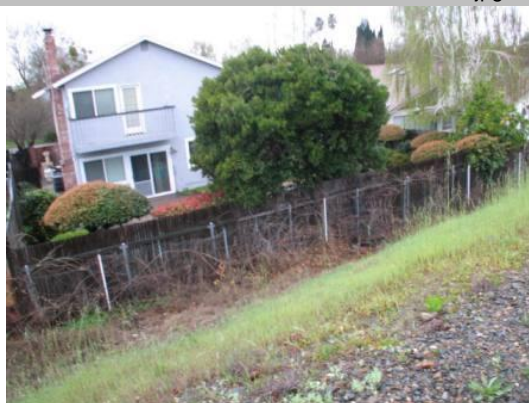
Photo 1 of 1 : mkhashch_s_20140428_00213.jpg

LM Start	10.73	Rating **	U	Issue No.	159
LM End	10.73	Issue Type +	En	Location *	LS
Category	Earthen Levee			GPS Latitude/Longitude	
				Start	End
Item	Encroachments			38.568313 °	38.568313 °
				-121.352941 °	-121.352941 °
DWR ID	DWR_NA0001_04_s _ 2012_159				
Action/Comments					
Fence					
Inspector Comments: Wooden privacy fence within 10-ft of levee toe.

03/16/2012 Wood privacy fence completely obstructs access and visibility.

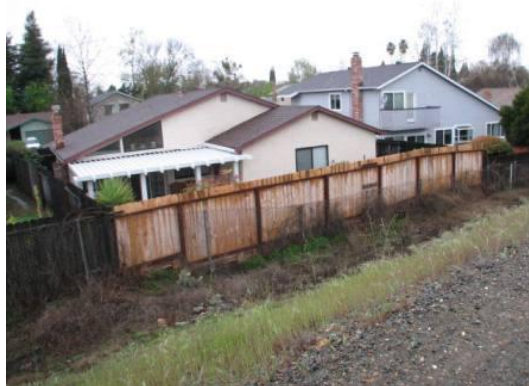
Photo 1 of 1 : mkhashch_s_20140428_00214.jpg

LM Start	10.74	Rating **	U	Issue No.	160
LM End	10.74	Issue Type +	En	Location *	LS
Category	Earthen Levee			GPS Latitude/Longitude	
				Start	End
Item	Encroachments			38.568188 °	38.568188 °
				-121.352864 °	-121.352864 °
DWR ID	DWR_NA0001_04_f_2012_160				
Action/Comments					
Fence					
Inspector Comments: Tall wooden privacy fence within 10-ft of levee toe.

03/16/2012 Wood privacy fence completely obstructs access and visibility.

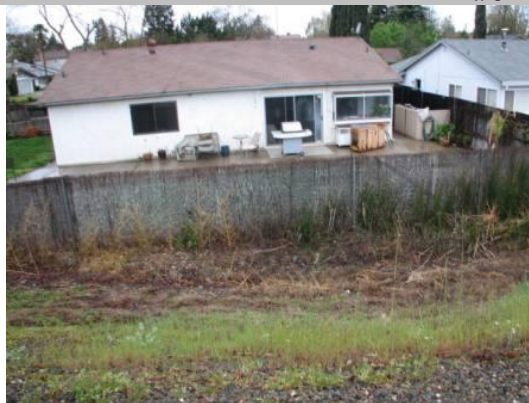
Photo 1 of 1 : mkhashch_s_20140428_00231.jpg

LM Start	10.77	Rating **	U	Issue No.	179
LM End	10.77	Issue Type +	En	Location *	LS
Category	Earthen Levee			GPS Latitude/Longitude	
				Start	End
Item	Encroachments			38.567917 °	38.567917 °
				-121.352698 °	-121.352698 °
DWR ID	DWR_NA0001_04_s _ 2012_179				
Action/Comments					
Fence Inspector Comments: Chainlink fence with bamboo mats prevent visibility.

03/16/2012 Bamboo panels on chainlink fence completely obstruct visibility.

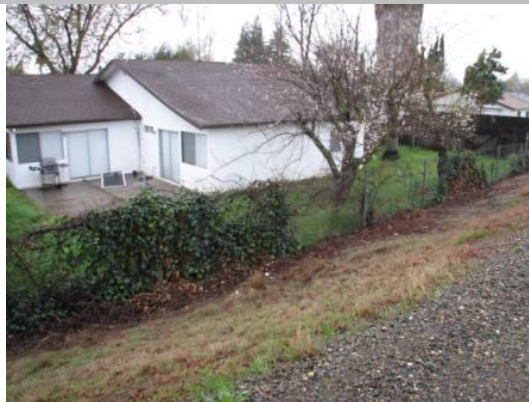
Photo 1 of 1 : mkhashch_s_20140428_00230.jpg

LM Start	10.79	Rating **	M	Issue No.	178
LM End	10.79	Issue Type +	En	Location *	LS
Category	Earthen Levee			GPS Latitude/Longitude	
				Start	End
Item	Encroachments			38.567552 °	38.567552 °
				-121.352500 °	-121.352500 °
DWR ID	DWR_NA0001_04_s _ 2012_178				
Action/Comments					
Fence					
Inspector Comments: Chainlink fence

03/16/2012 Chainlink fence partially blocks visibility.

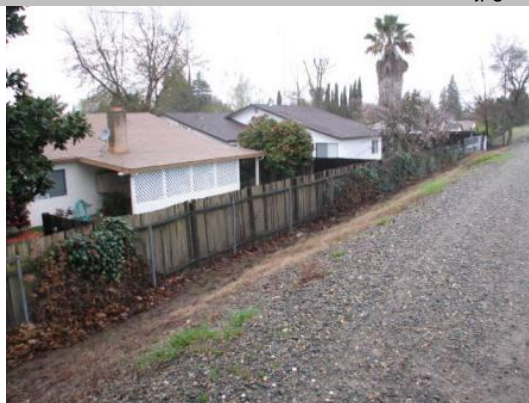
Photo 1 of 1 : mkhashch_s_20140428_00216.jpg

LM Start	10.80	Rating **	U	Issue No.	162
LM End	10.80	Issue Type +	En	Location *	LS
Category	Earthen Levee			GPS Latitude/Longitude	
				Start	End
Item	Encroachments			38.567402 °	38.567402 °
				-121.352415 °	-121.352415 °
DWR ID	DWR_NA0001_04_s_2012_162				
Action/Comments					
Fence					
Inspector Comments: Wooden privacy fence within 10-ft of levee toe.

03/16/2012 Wood privacy fence completely obstructs access and visibility.

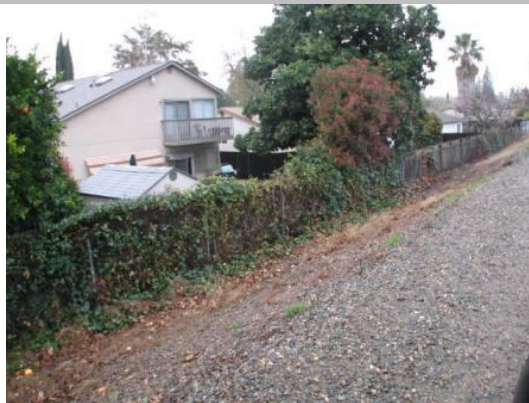
Photo 1 of 1 : mkhashch_s_20140428_00217.jpg

LM Start	10.82	Rating **	U	Issue No.	163
LM End	10.82	Issue Type +	En	Location *	LS
Category	Earthen Levee			GPS Latitude/Longitude	
				Start	End
Item	Encroachments			38.567250 °	38.567250 °
				-121.352341 °	-121.352341 °
DWR ID	DWR_NA0001_04_s_2012_163				
Action/Comments					
Fence					
Inspector Comments: Wooden privacy fence and landscaping within 10-ft of levee toe.

03/16/2012 Wood privacy fence completely obstructs access and visibility.

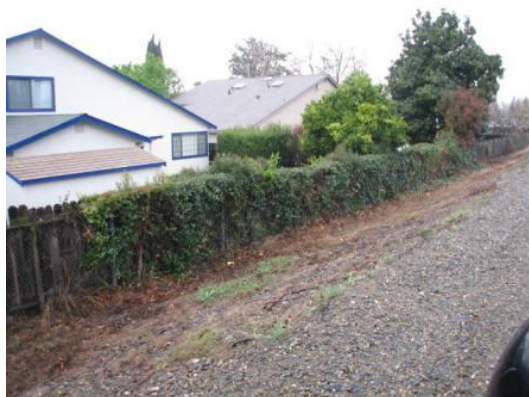
Photo 1 of 1 : mkhashch_s_20140428_00225.jpg

LM Start	10.83	Rating **	U	Issue No.	172
LM End	10.83	Issue Type +	En	Location *	LS
Category	Earthen Levee			GPS Latitude/Longitude	
				Start	End
Item	Encroachments			38.567008 °	38.567008 °
				-121.352226 °	-121.352226 °
DWR ID	DWR_NA0001_04_s_2012_172				
Action/Comments					
Fence					
Inspector Comments: Wooden privacy fence.

03/16/2012 Wood privacy fence completely obstructs access and visibility.

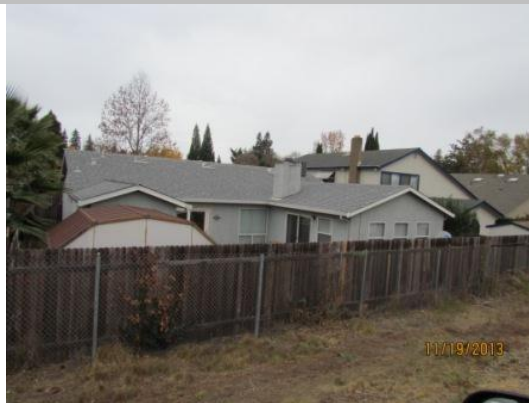
Photo 1 of 1 : mkhashch_s_20140428_00223.jpg

LM Start	10.84	Rating **	U	Issue No.	170
LM End	10.84	Issue Type +	En	Location *	LS
Category	Earthen Levee			GPS Latitude/Longitude	
				Start	End
Item	Encroachments			38.566981 °	38.566981 °
				-121.352213 °	-121.352213 °
DWR ID	DWR_NA0001_04_f_2012_170				
Action/Comments					
Fence					
Inspector Comments: Wooden privacy fence within 10-ft of levee toe.

View of the fence obstructing visibility and access.

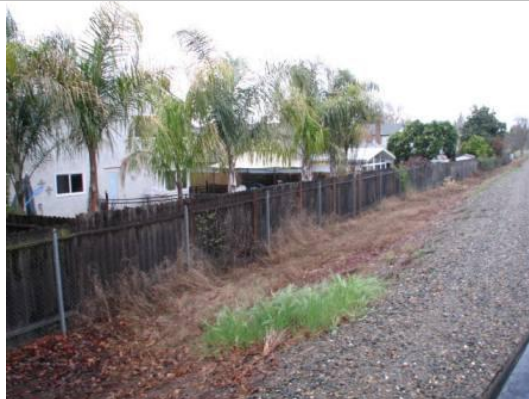
Photo 1 of 1 : mkhashch_s_20140428_00219.jpg

LM Start	10.86	Rating **	U	Issue No.	166
LM End	10.86	Issue Type +	En	Location *	LS
Category	Earthen Levee			GPS Latitude/Longitude	
				Start	End
Item	Encroachments			38.566705 °	38.566705 °
				-121.352063 °	-121.352063 °
DWR ID	DWR_NA0001_04_s_2012_166				
Action/Comments					
Fence					
Inspector Comments: Wooden privacy fence within 10-ft of levee toe.

03/16/2012 Wood privacy fence completely obstructs access and visibility.

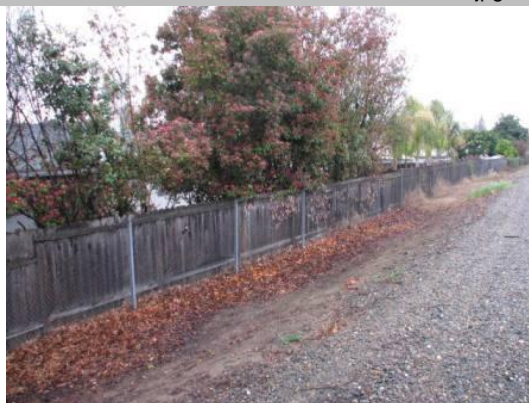
Photo 1 of 1 : mkhashch_s_20140428_00224.jpg

LM Start	10.87	Rating **	U	Issue No.	171
LM End	10.87	Issue Type +	En	Location *	LS
Category	Earthen Levee			GPS Latitude/Longitude	
				Start	End
Item	Encroachments			38.566545 °	38.566545 °
				-121.352004 °	-121.352004 °
DWR ID	DWR_NA0001_04_s _ 2012_171				
Action/Comments					
Fence Inspector Comments: Wooden privacy fence and tall hedge within 10-ft of levee toe.

03/16/2012 Wood privacy fence completely obstructs access and visibility.

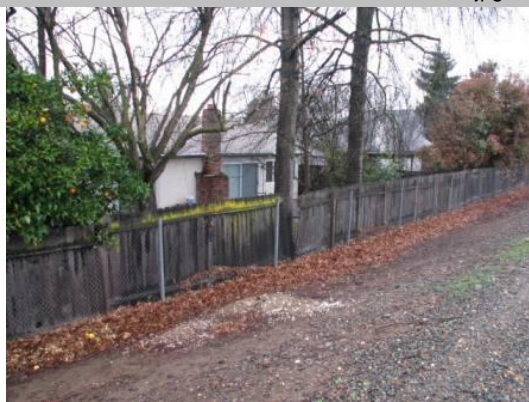
Photo 1 of 1 : mkhashch_s_20140428_00222.jpg

LM Start	10.88	Rating **	U	Issue No.	169
LM End	10.88	Issue Type +	En	Location *	LS
Category	Earthen Levee			GPS Latitude/Longitude	
				Start	End
Item	Encroachments			38.566399 °	38.566399 °
				-121.351931 °	-121.351931 °
DWR ID	DWR_NA0001_04_s _ 2012_169				
Action/Comments					
Fence					
Inspector Comments: Wooden privacy fence within 10-ft of levee toe.

03/16/2012 Wood privacy fence completely obstructs access and visibility.

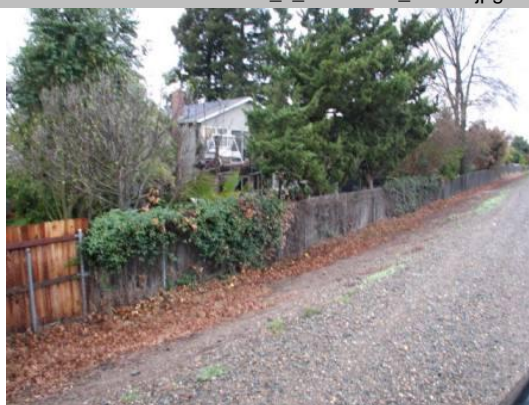
Photo 1 of 1 : mkhashch_s_20140428_00220.jpg

LM Start	10.89	Rating **	U	Issue No.	167
LM End	10.89	Issue Type +	En	Location *	LS
Category	Earthen Levee			GPS Latitude/Longitude	
				Start	End
Item	Vegetation			38.566233 °	38.566233 °
				-121.351848 °	-121.351848 °
DWR ID	DWR_NA0001_04_s_2012_167				
Action/Comments					
Landscaping Inspector Comments: Wooden privacy fence ivy and vine planted within 10-ft of levee toe.

03/16/2012 Wood privacy fence completely obstructs access and visibility.

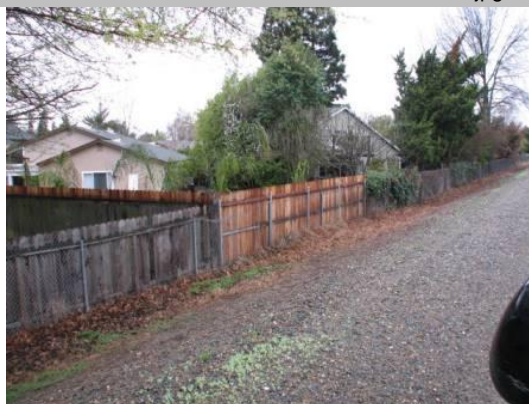
Photo 1 of 1 : mkhashch_s_20140428_00218.jpg

LM Start	10.91	Rating **	U	Issue No.	165
LM End	10.91	Issue Type +	En	Location *	LS
Category	Earthen Levee			GPS Latitude/Longitude	
				Start	End
Item	Encroachments			38.566044 °	38.566044 °
				-121.351747 °	-121.351747 °
DWR ID	DWR_NA0001_04_s_2012_165				
Action/Comments					
Fence					
Inspector Comments: Wooden privacy fence within 10-ft of levee toe.

03/16/2012 Wood privacy fence completely obstructs access and visibility.

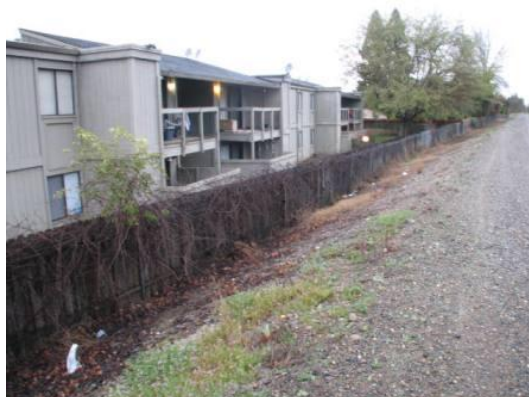
Photo 1 of 1 : mkhashch_s_20140428_00221.jpg

LM Start	10.92	Rating **	U	Issue No.	168
LM End	10.94	Issue Type +	En	Location *	LS
Category	Earthen Levee			GPS Latitude/Longitude	
				Start	End
Item	Encroachments			38.565917 °	38.565646 °
				-121.351682 °	-121.351532 °
DWR ID	DWR_NA0001_04_s _ 2012_168				
Action/Comments					
Fence					
Inspector Comments: Wooden privacy fence within 10-ft of levee toe.

03/16/2012 Wood privacy fence completely obstructs access and visibility.

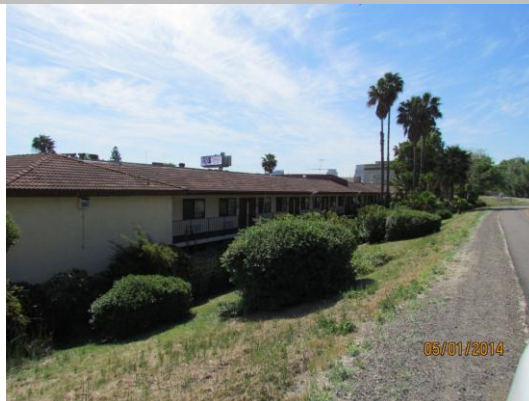
Photo 1 of 1 : mkhashch_s_20140509_00978.jpg

LM Start	0.10	Rating **	M	Issue No.	2
LM End	0.16	Issue Type +	En	Location *	LS
Category	Earthen Levee			GPS Latitude/Longitude	
				Start	End
Item	Vegetation			38.595044 °	38.594117 °
				-121.506497 °	-121.506377 °
DWR ID	DWR_NA0001_05_s _ 2012_2				
Action/Comments					
Landscaping					
Inspector Comments: Landscaping behind Best Western.

View of the landscaping on the landside levee slope obstructing visibility and access.

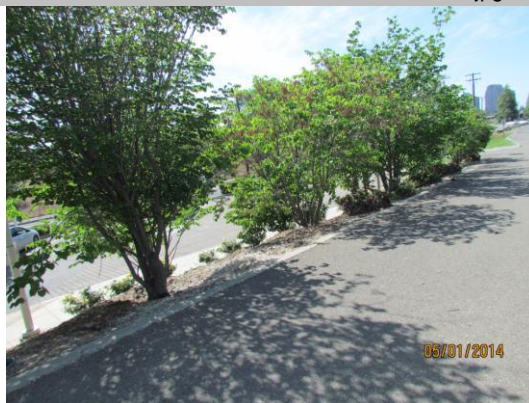
Photo 1 of 1 : mkhashch_s_20140509_00979.jpg

LM Start	0.27	Rating **	M	Issue No.	5
LM End	0.35	Issue Type +	En	Location *	LS
Category	Earthen Levee			GPS Latitude/Longitude	
				Start	End
Item	Vegetation			38.592630 °	38.591517 °
				-121.505850 °	-121.505447 °
DWR ID	DWR_NA0001_05_s _ 2012_5				
Action/Comments					
Landscaping					
Inspector Comments: Landscaping at City intake facility.

View of the landscaping on the landside levee slope at the City intake facility.

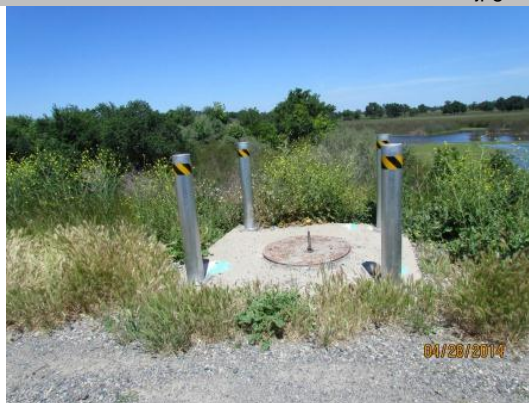
Photo 1 of 1 : mkhashch_s_20140505_00941.jpg

LM Start	0.01	Rating **	A/W	Issue No.	10
LM End	0.01	Issue Type +	En	Location *	CR
Category	Earthen Levee			GPS Latitude/Longitude	
				Start	End
Item	Encroachments			38.657424 °	38.657424 °
				-121.474434 °	-121.474434 °
DWR ID	DWR_NA0001_06_s_2014_10				
Action/Comments					
Pipe

View of the pipe from the levee crown.

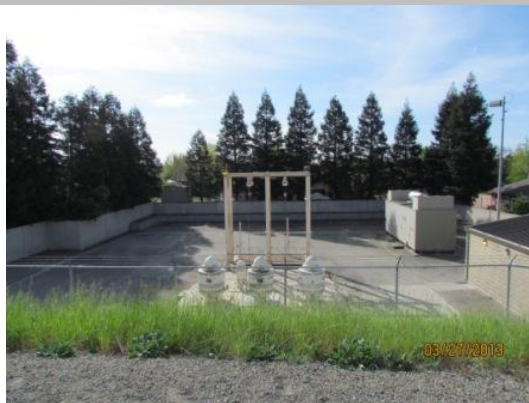
Photo 1 of 1 : mkhashch_s_20140428_00289.jpg

LM Start	0.60	Rating **	A/W	Issue No.	8
LM End	0.60	Issue Type +	En	Location *	LS
Category	Earthen Levee			GPS Latitude/Longitude	
				Start	End
Item	Encroachments			38.659649 °	38.659649 °
				-121.464167 °	-121.464167 °
DWR ID	DWR_NA0001_06_s_2013_8				
Action/Comments					
Pipe

View of the pumping plant at the landside levee toe.

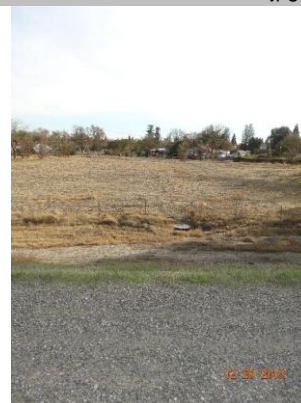
Photo 1 of 1 : UCIP_6198.jpg

LM Start	0.83	Rating **	M	Issue No.	9
LM End	0.83	Issue Type +	En	Location *	LS
Category	Supplemental			GPS Latitude/Longitude	
				Start	End
Item	DWR UCIP Field Study			38.661156 °	38.661156 °
				-121.460475 °	-121.460475 °
DWR ID	DWR_NA0001_06_s _ 2014_9				
Action/Comments					
Inspector Comments: FS_ID:29223					
EP_NO: N/A					
Repair Type:					
Crossing Status:					
UCIP Comments: Unable to find CM riser and flap gate on waterward end--need to contact owner to determine status of crossing. Manhole found on landward side however unable to determine if manhole is part of this crossing.					
FIELD_STRUCT_DESC: 24-inch pipe through the levee, 12.5 feet below the crown. Two CM cutoff walls around pipe. Slide gate in CM riser and flap gate at waterward end. Concrete headwalls on both ends. (USACE-1959). This entry matches the Drainage or Irrigation Structure referenced in O&M manual (Station 440+50).

View of landward side--manhole on landward toe.

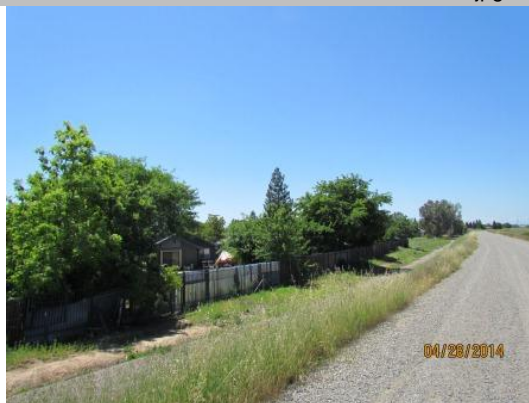
Photo 1 of 1 : mkhashch_s_20140505_00940.jpg

LM Start	0.96	Rating **	M	Issue No.	7
LM End	0.96	Issue Type +	Ma	Location *	LS
Category	Earthen Levee			GPS Latitude/Longitude	
				Start	End
Item	Vegetation			38.662114 °	38.662114 °
				-121.458576 °	-121.458576 °
DWR ID	DWR_NA0001_06_s _ 2014_7				
Action/Comments					
Control annual grass and weeds on the levee slopes and easements.

View of the tall vegetation on the landside levee slope.
